Subject: E387 Error Code

Models: DVM, CHILLER

Title: Hall Sensor (RPM sensor) in Outdoor Fan Motor 2

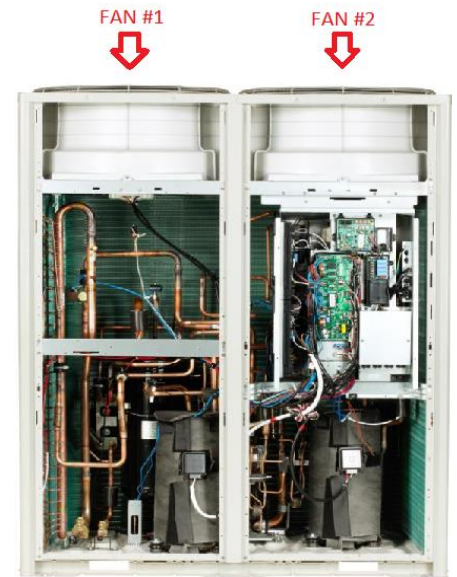
Fan #2 is on the right-hand side of unit

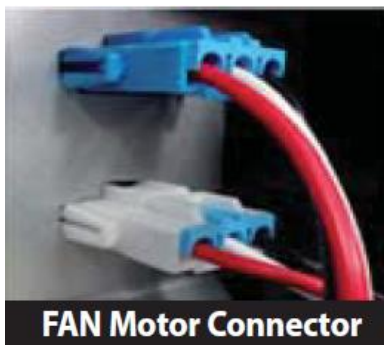
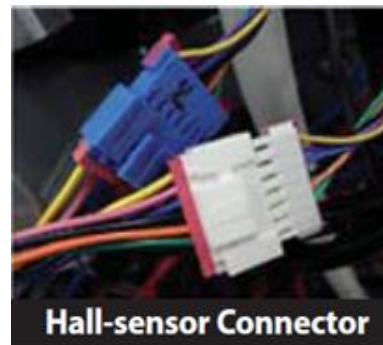
1. Remove power to the condensing unit for a minimum of 15 minutes.
2. Inspect the fan blade and make sure there are no obstructions.
3. Verify blade spins freely.
4. There are two plug connections for each fan motor. Power (red, white, and black) and hall effect sensor.
5. Follow and inspect wiring. Make sure there is no damage to wires or plugs.
6. Make sure all plugs and spade connectors are secure and connected properly.
7. Disconnect power plug (Fan motor 1 is white plug, Fan motor 2 is blue plug) Check resistance at plug going to Fan motor. Red-White, Red- Black and White to Black. The resistance value between each winding should be equal, under 10Ω and open to ground

1. Reverse connector plugs for Fan motor 1 and Fan motor 2. (Fan Motor and Hall Effect plug)
2. Restore power to the unit. If the E387 error returns, replace fan PCB. If the error changes to E487, replace the fan motor.

1. Remove power from unit for minimum of 15 minutes. Remove Fan connections from Fan PCB and connect inverter checker.
2. Restore power to unit Press K2 button 12 times to initiate the inverter test for fan motor 2.
3. If the inverter test fails, replace Fan PCB. If it passes, replace Fan motor.
